# Observing the significance and benefits of oil performance in reducing engine coking in CFM56-5B engines

Juneyao Airlines

Juneyao Airlines elected to perform the oil systems review on a CFM56-5B4/P engine from an A320-200 aircraft. The engine was removed and sent to General Electric's Strother, Kansas, repair and overhaul facility for disassembly, inspection, and overhaul.

This review pictorially captures and documents, using photographs and borescope, the overall condition of the exposed lubricating system of an engine operated exclusively with Eastman Turbo Oil 2197 since new.

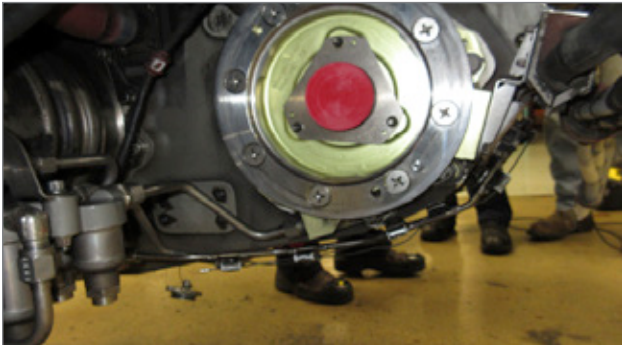
ATS drive pad

All line-replaceable units (LRUs) were removed from the AGB with the exception of the fuel control unit (FCU), and the exposed drive pads showed no evidence of oil leakage.

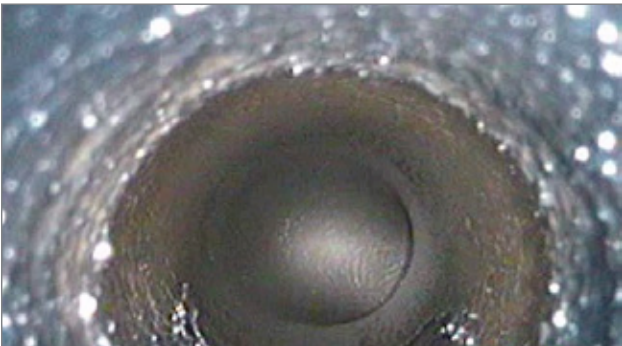
The supply tube inspection was documented through a borescope video that is available for review. Despite 30,312 hours and 15,080 cycles on the engine, the supply tube borescope showed a very minor buildup of deposits in this pressure tube and only a small amount of varnishing. The tube was estimated to be at least 98% open.

Typically the #5 oil supply tube suffers coking predominately in the area around the elbow and locating flange due to heat conduction from the TRF.

Supply tube view from the locating flange area towards the elbow transition

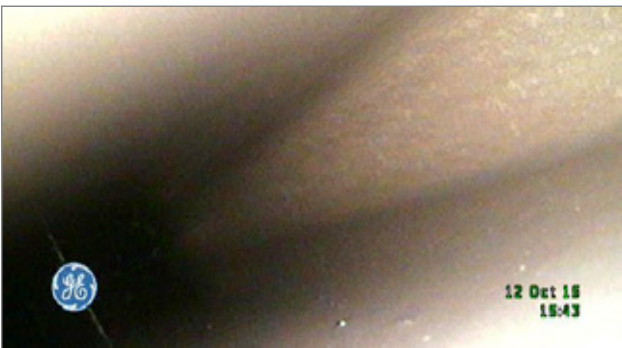
Metal clean scavenge tube

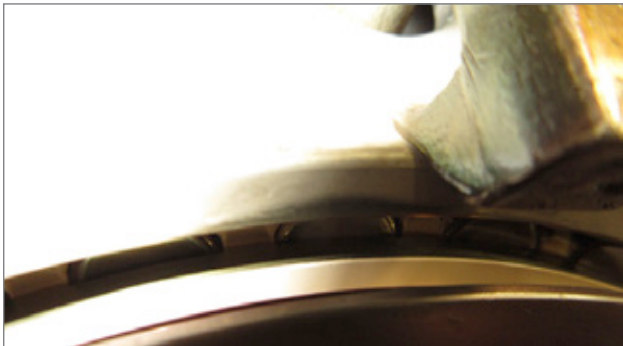
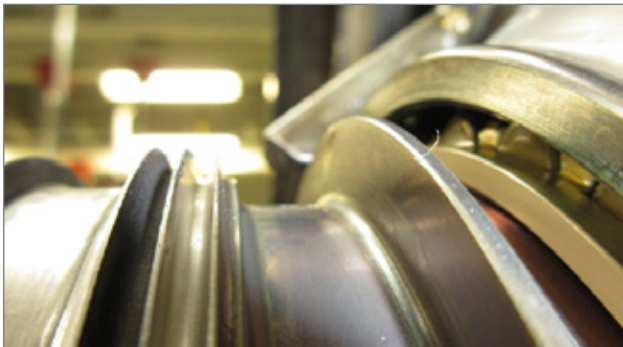
Bearing #3

During the engine disassembly process, there was minimal entry to #3 bearing; however, the visible portions, including the bearings, races, and compartments were very clean.

The inspectors had minimal access to bearing #3; however, what was exposed was very clean, as evidenced in the following images.

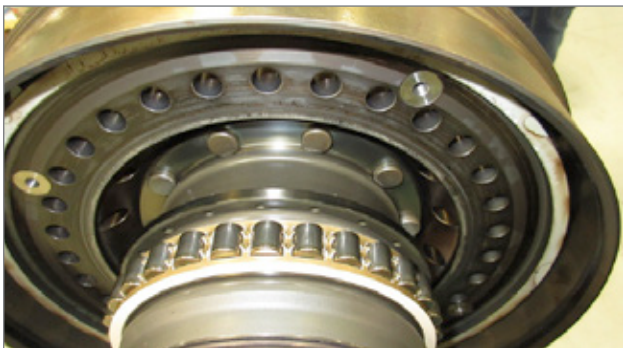
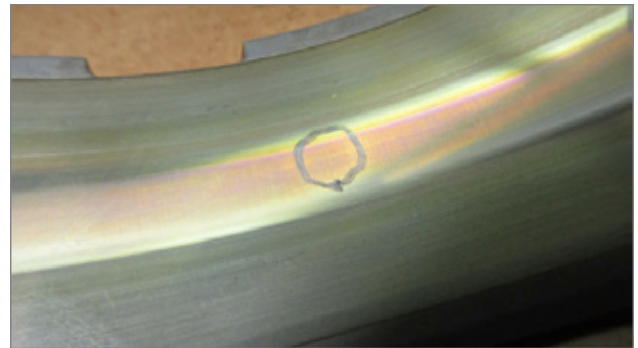
Overall, the bearings, races, and compartments were very clean. Some of the bearings, however, did show some imperfections. For example, the #4 bearing's outer-race inner diameter showed some pitting that will require extra work.

Bearing #4 outer-race ID

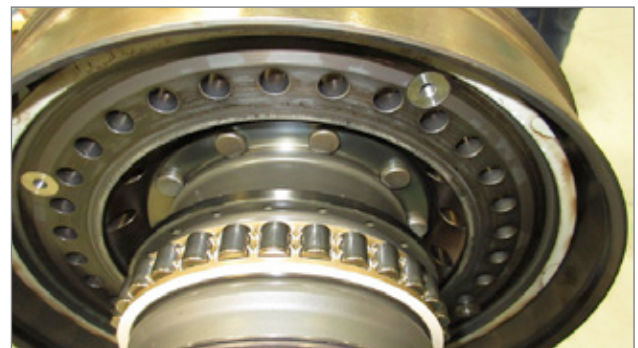
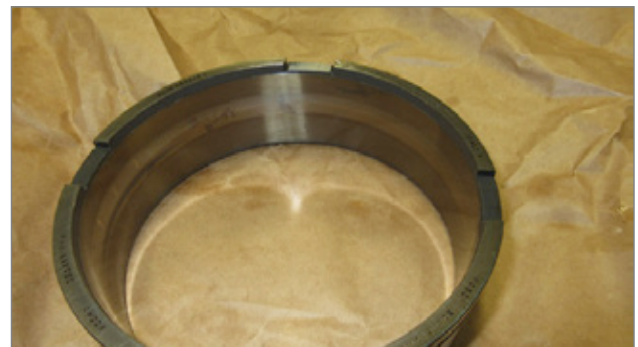
In contrast, the #5 bearing's outer-race inner diameter showed no signs of damage during the inspection when seen by the naked eye.

Bearing #5 outer-race ID
